Case Study 1

Outlier for unexpected failure to ignite sample on needle flame test in 18e29.

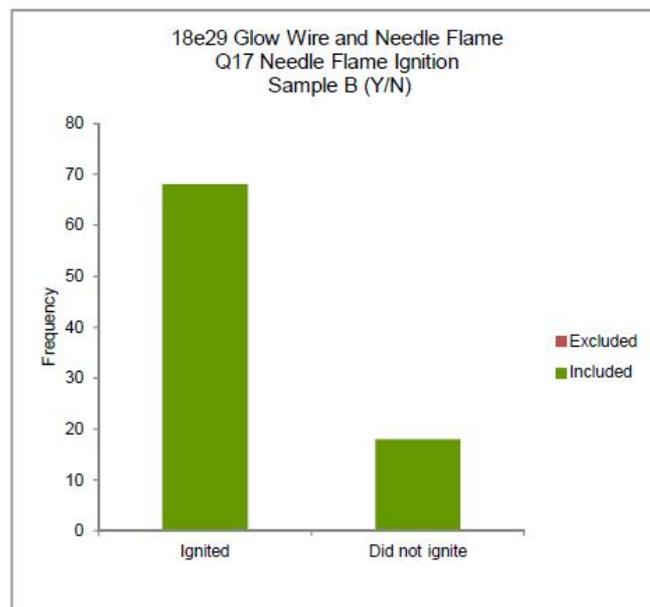
1. In the instructions it says: "The needle flame shall be applied to the planar surface of the specimen as shown in Figure 1c of the standard. The apparatus shall be perpendicular to the centre of the planar surface of the specimen. DO NOT TEST THE EDGES OF THE SPECIMENS." Please help confirm whether needle flame pic. 1 as attached is the correct position of the test sample.

(pic 1 was sample tested in the middle, pic 2 was sample tested at the edges.)

(IFM Reply: 1. Picture 1.)
